memorandum

date October 11, 2023
to Rosanne Humphrey, City of Carlsbad
cc Karla Alcaraz, Environmental Science Associates
from Adrienne Lee, Environmental Science Associates
subject Roadkill Study Results – Rancho Santa Fe and El Camino Real

This memorandum summarizes the results of roadkill monitoring along Rancho Santa Fe Road and El Camino Real for one year from November 2021 to November 2022.

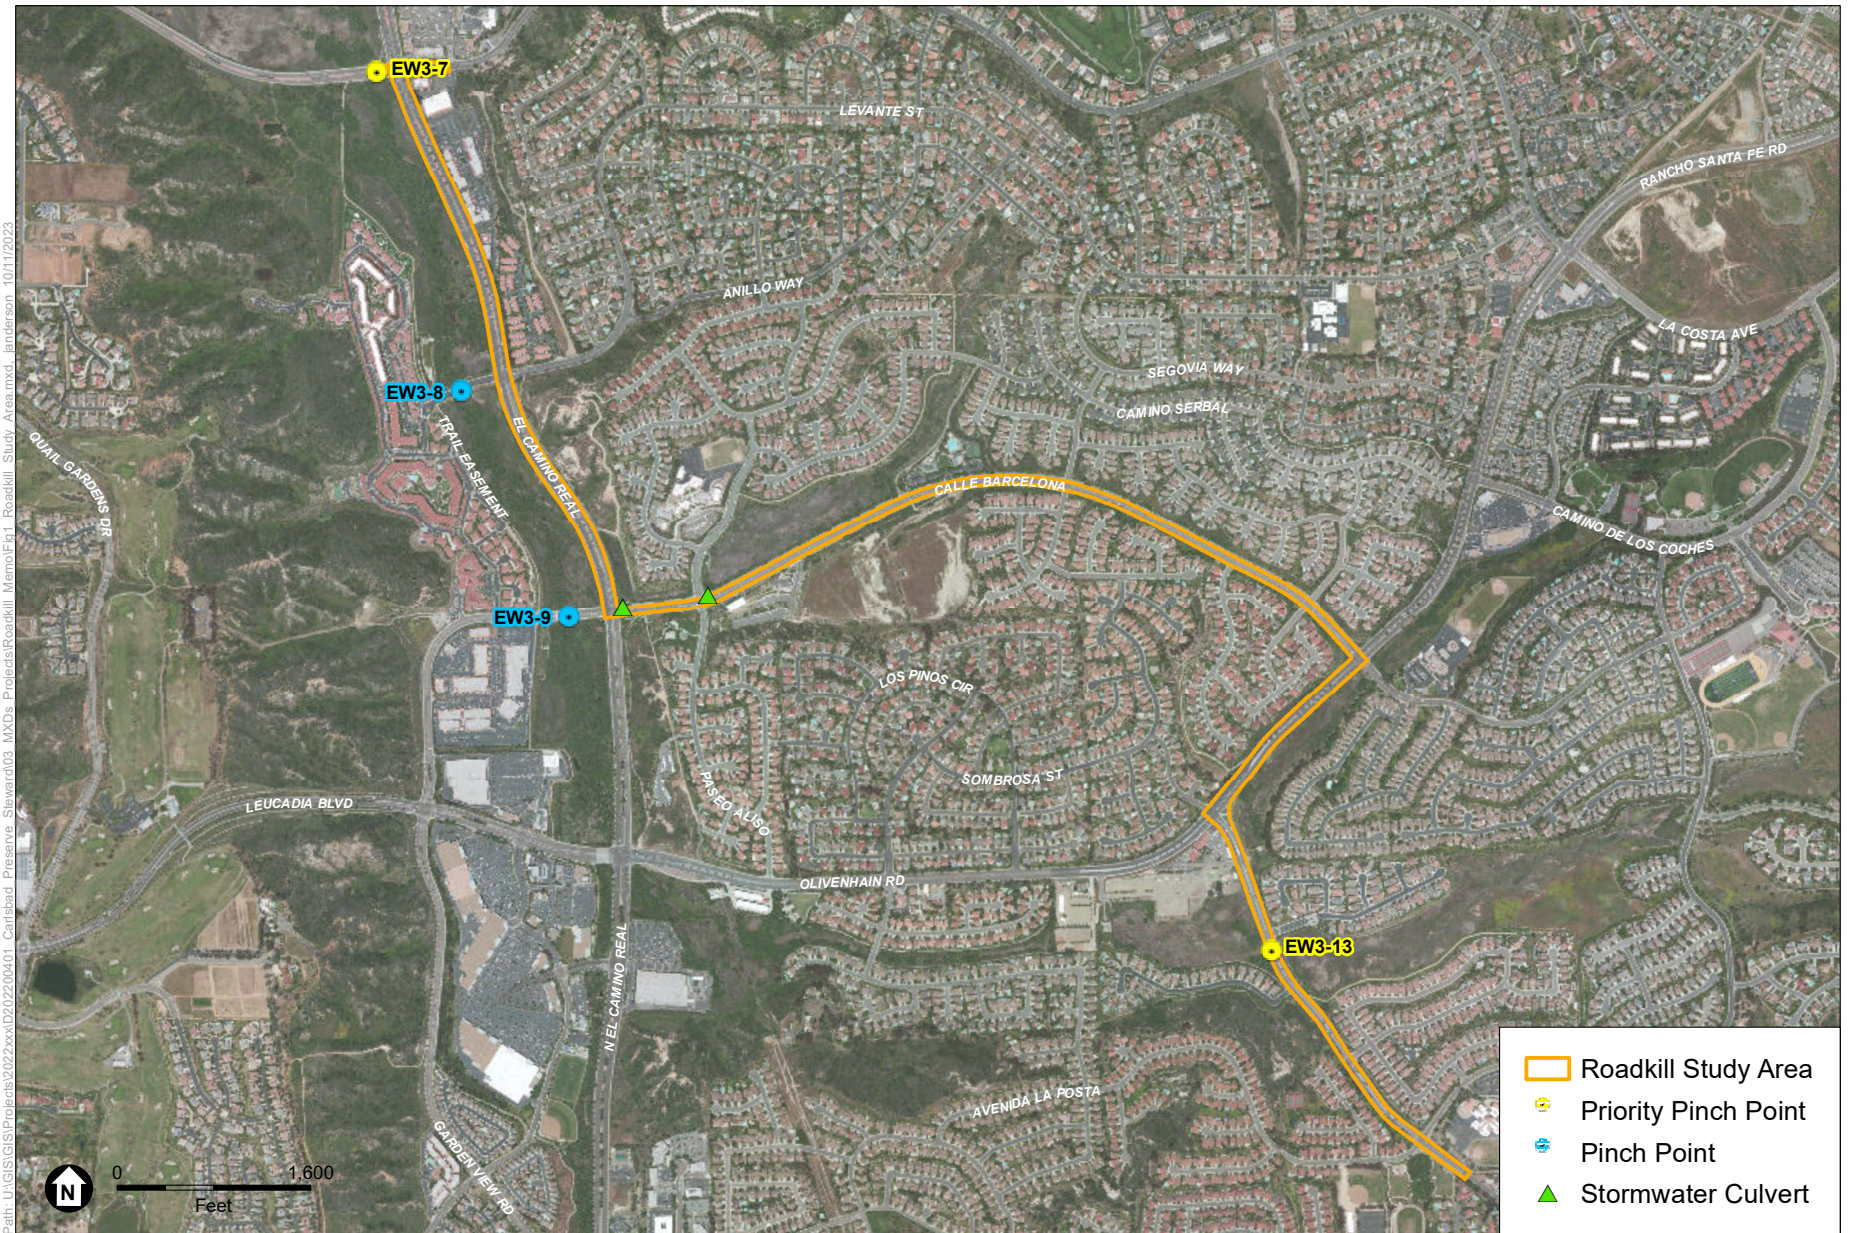
Figure 1
Rancho Santa Fe Road and El Camino Real Roadkill Survey Area

On November 15, 2021, ESA biologists, Preserve Calavera volunteers, and the city’s Habitat Management Program staff finalized the survey area (Figure 1). The survey area—from Gelson’s shopping area off La Costa Avenue, west to the El Camino Real intersection, south on El Camino Real until Calle Barcelona, east on Calle Barcelona until Rancho Santa Fe Road, and south on Rancho Santa Fe Road until Olivenhain Pioneer Elementary School—was monitored for one year from November 15, 2021, to November 15, 2022, with a minimum of two surveys completed per week.

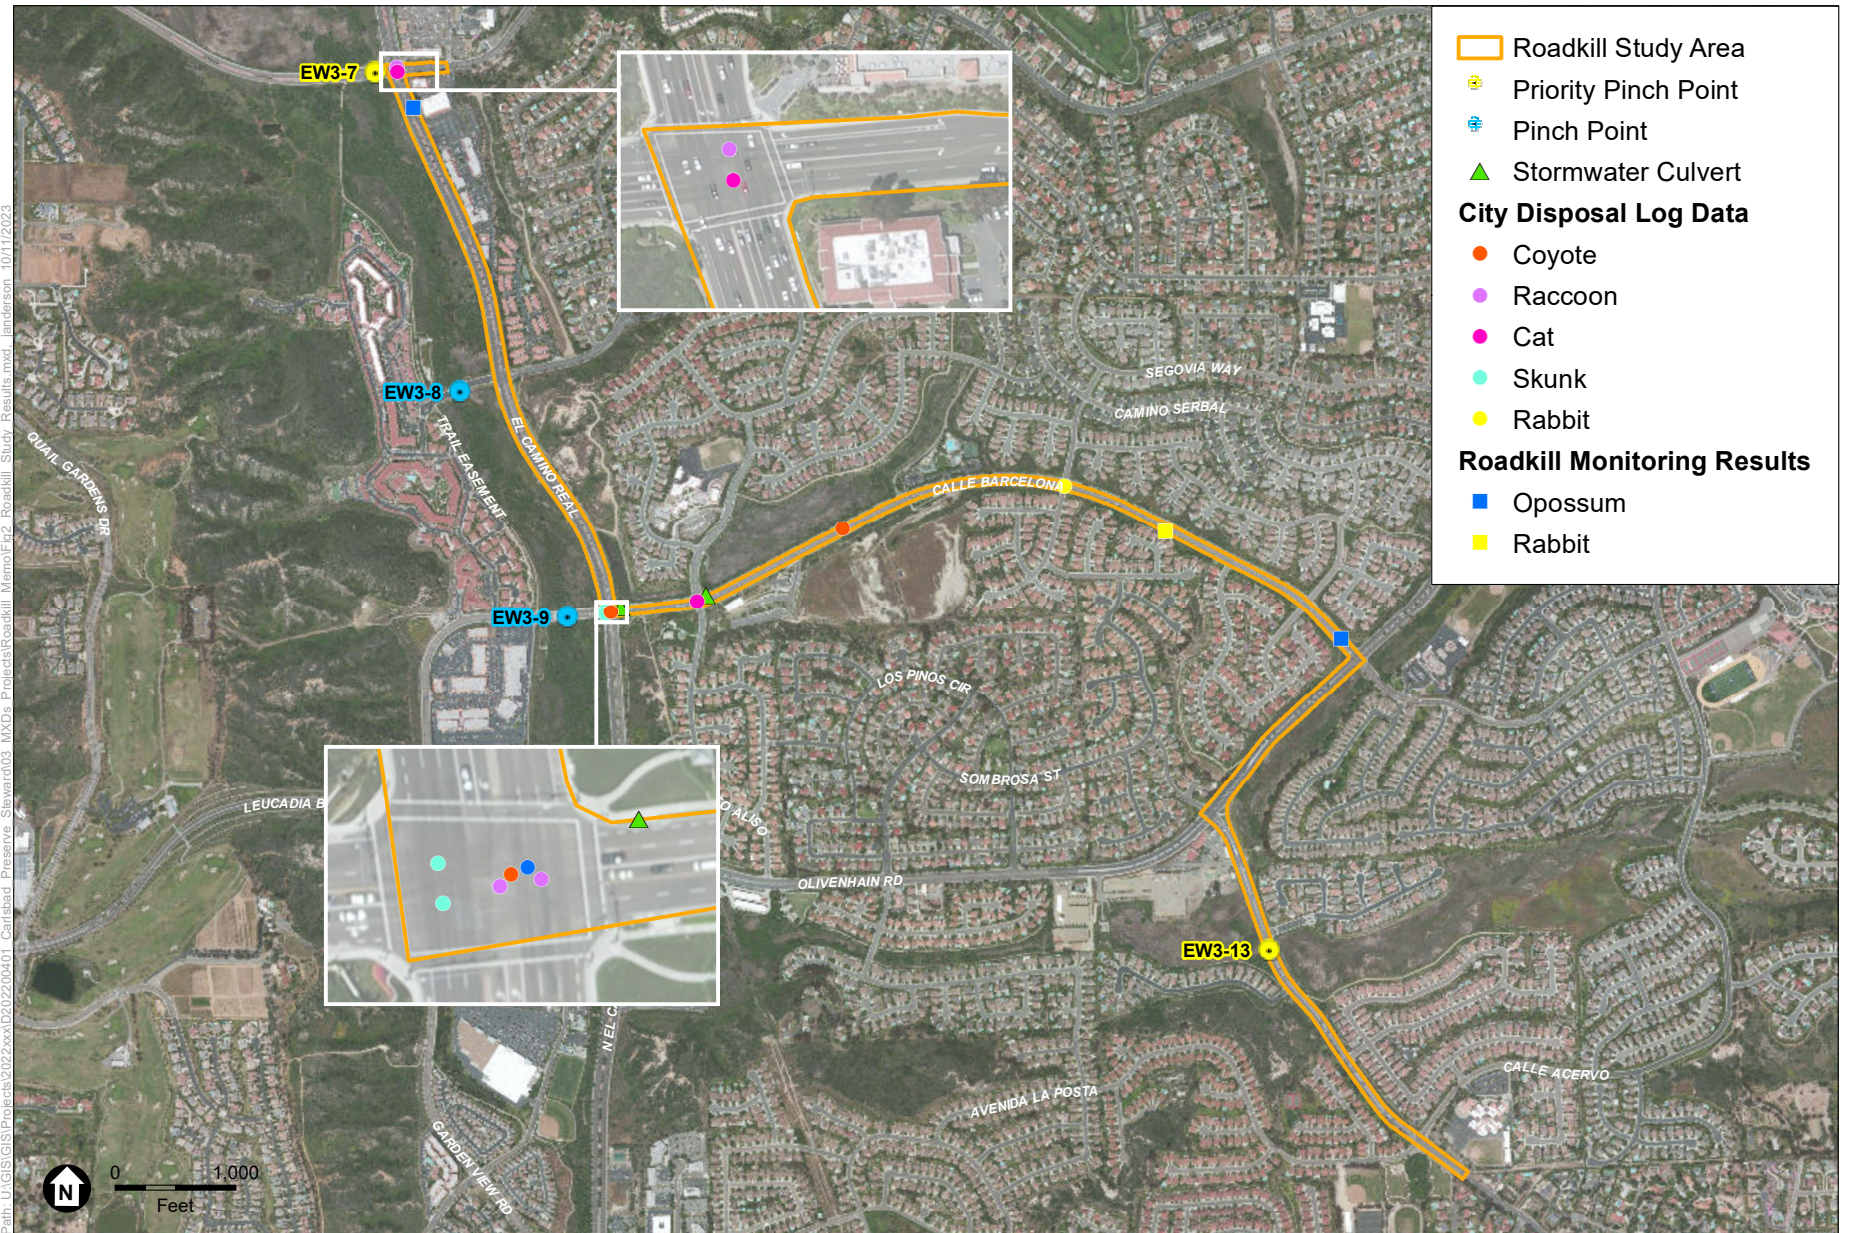
Figure 2
Roadkill Monitoring Results

Twelve roadkill occurrences were recorded during the survey year. The recorded instances included various animal species, such as skunks, rabbits, coyotes, opossums, cats, and raccoons. Of these incidents, ten were small- to medium-sized mammals (rabbits, opossums, skunks, raccoons, and cats) and two were medium- to large-sized mammals (coyotes). All roadkill observations and their associated survey dates, surveyor information, and locations are listed in **Table 1**. Locations of all roadkill observations are displayed in **Figure 2** (see Attachment A).

- **Priority pinch point.** EW3-9 has potential barriers that limit wildlife movement underneath the EW3-9 bridge, causing wildlife to cross at grade at the El Camino Real and Calle Barcelona intersection. This is evidenced by the six roadkill detections at the intersection, ranging from small to medium wildlife species (opossum, raccoon, and skunk) to medium to large wildlife species (coyote).
